# Lower Baker Dam Leakage Investigations

**Jim Sammet, PE**  
**Lower Baker Dam Capital Program Manager**

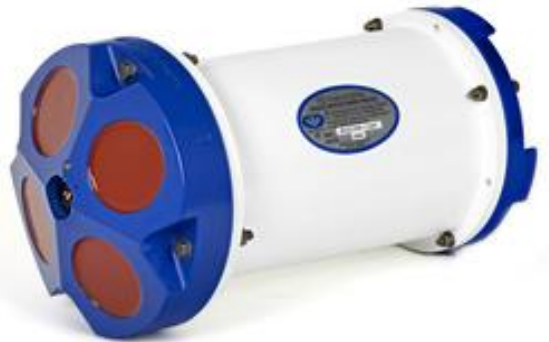
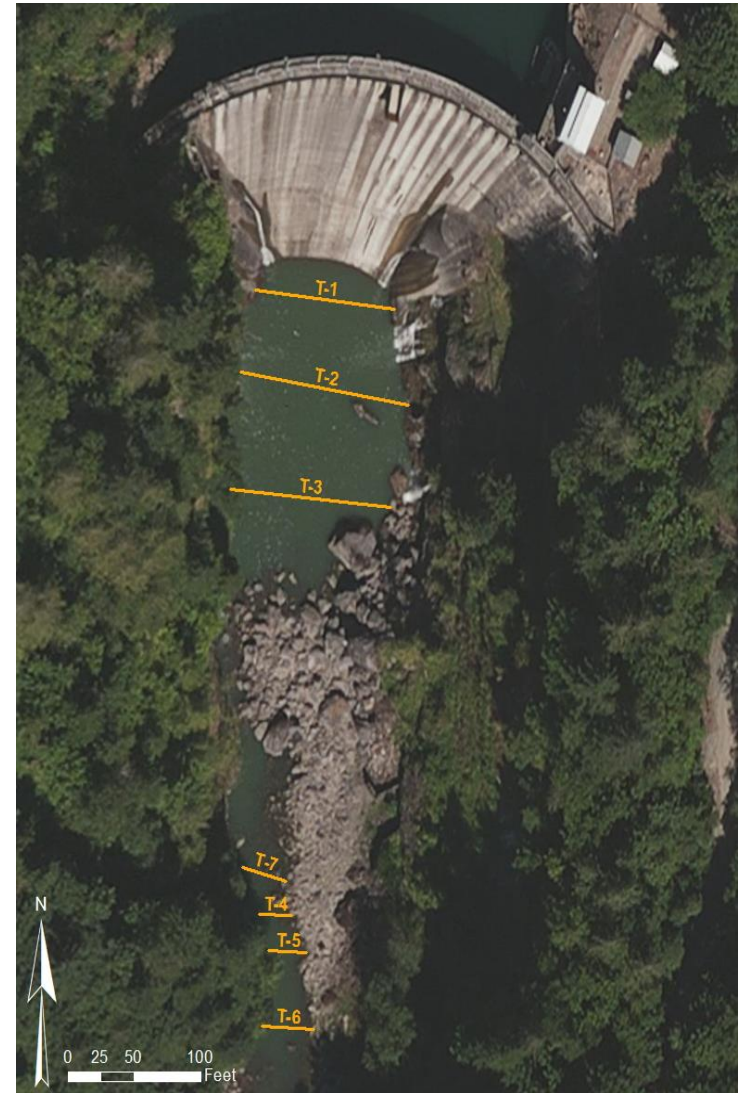
- **2007-2012 Acoustic Doppler Current Profiling**
- Technology uses acoustic beams along a transect to estimate velocities within the water column
- Accuracy Issues – results varied widely in a given year but seem to indicate an increase

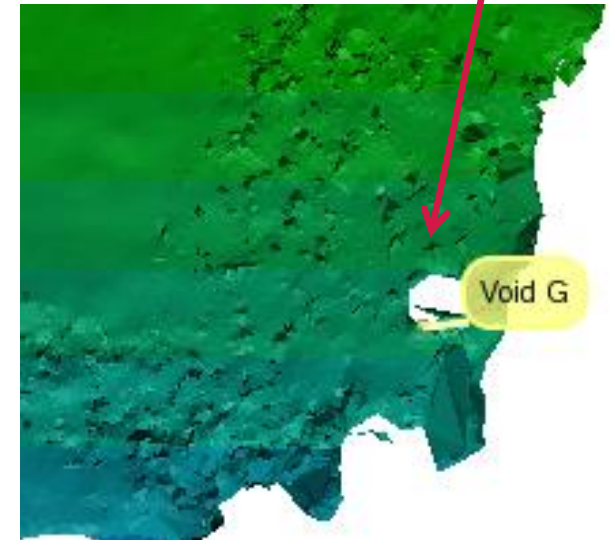
## Downstream Apron Mapping

- Blu-Vu Scan of D.S. apron
- Able to map known voids
- Monitor changes in future scans

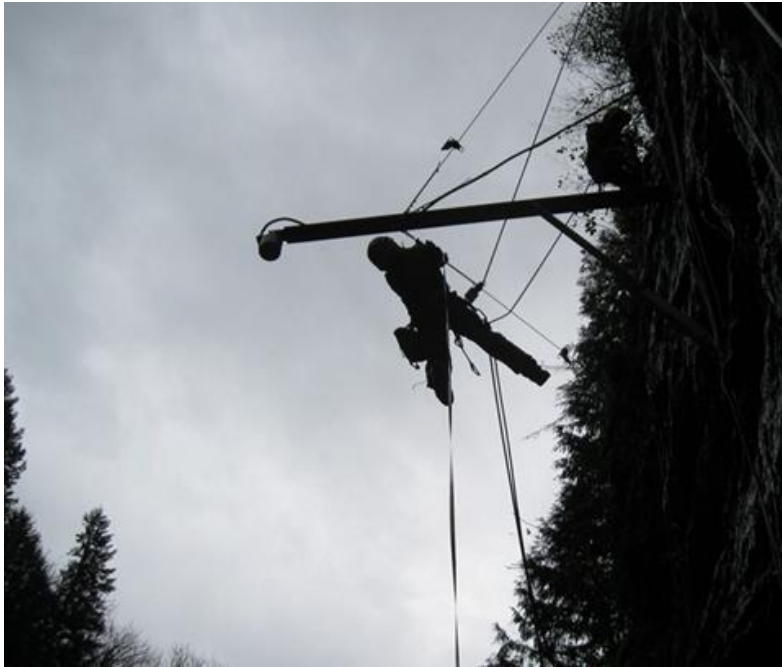
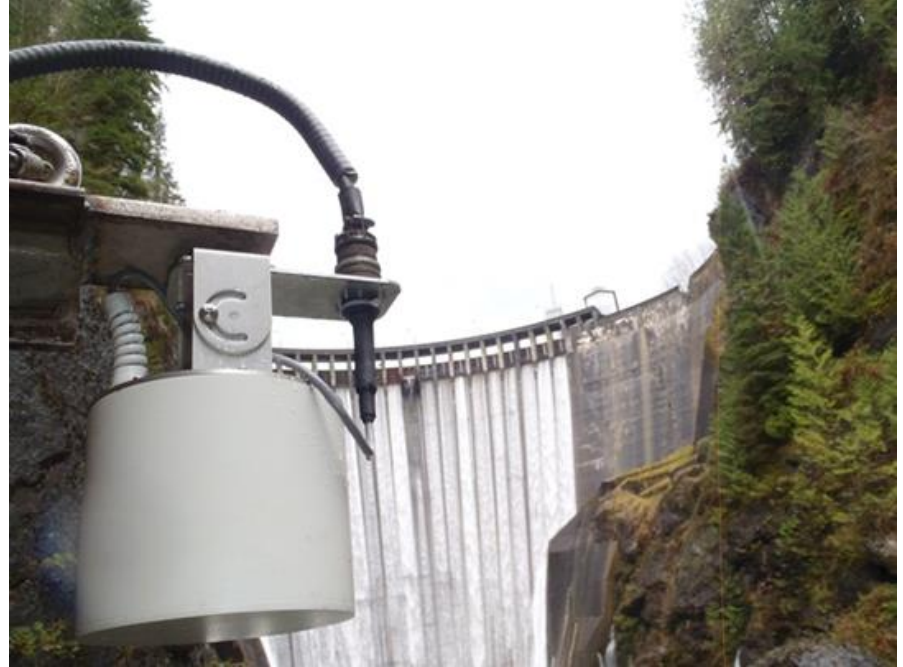
- Installed in November 2012 to support the early detection warning system and monitor leakage.
- Re-purposed in 2014 to primarily monitor leakage
- Measures leakage rate to within 3 or 4% of actual flow
- Rate is dependent upon pool elevation with max rate of 138cfs

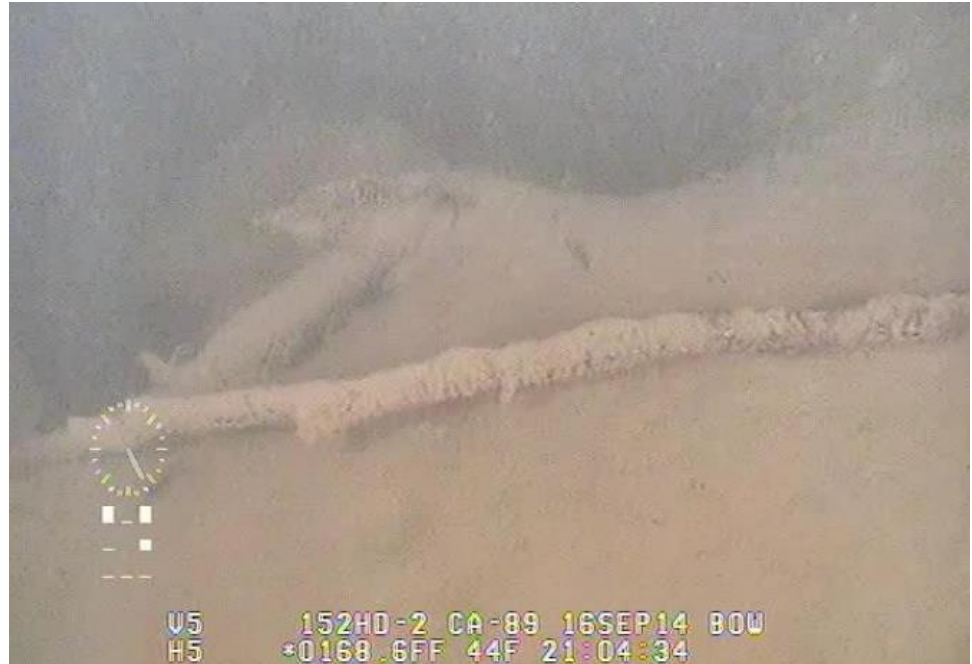
- ROV video reconnaissance of forebay depression
- High resolution Blue-Vu scanning of depression

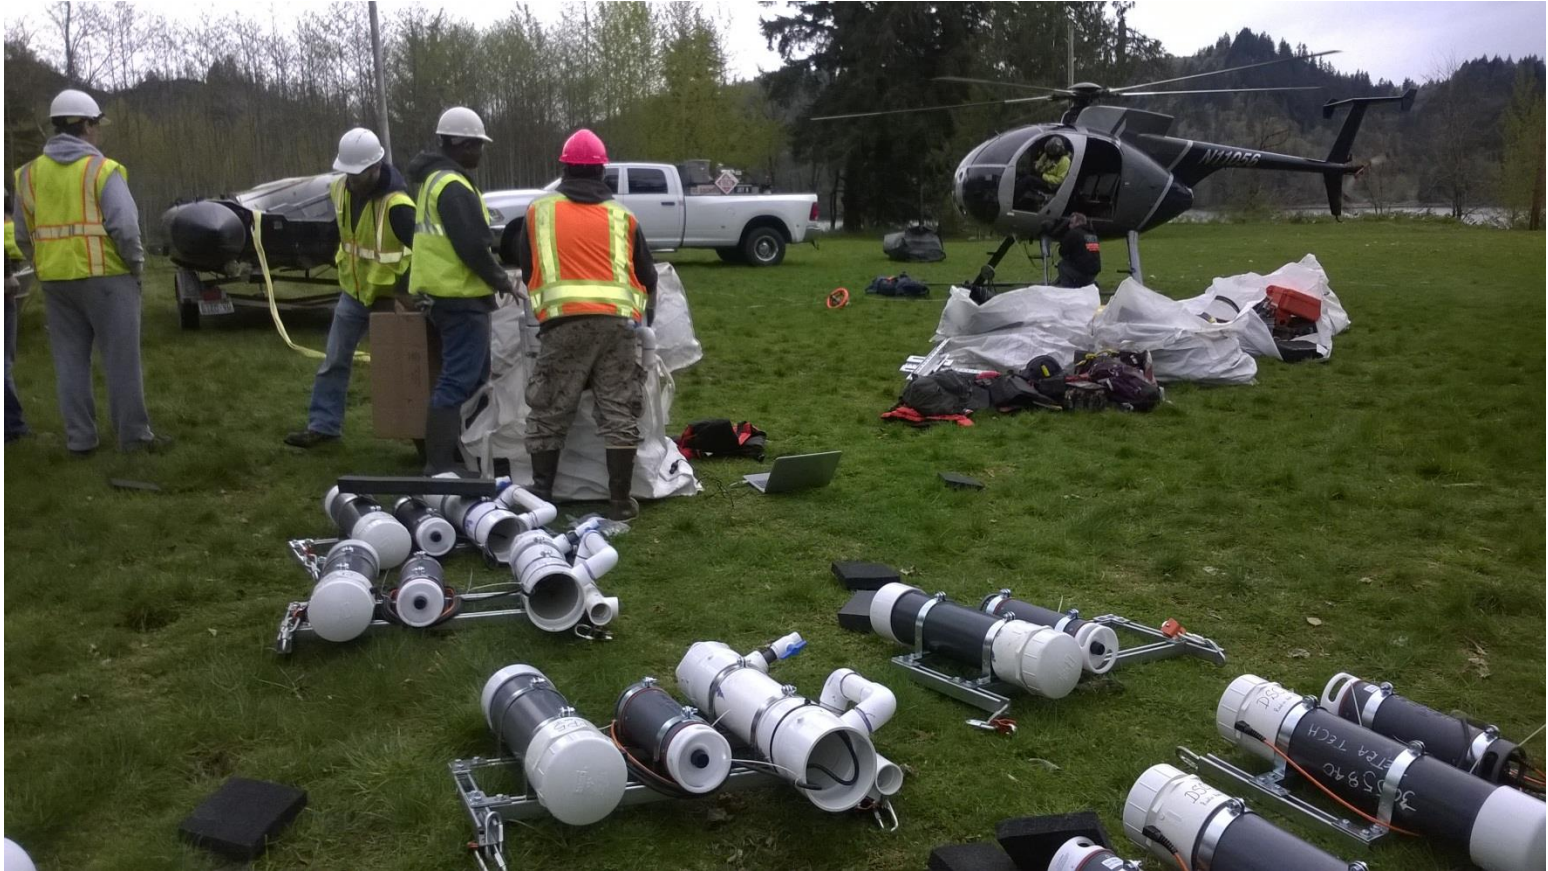
**Staging Plunge Pool Dye Sensing Equipment**

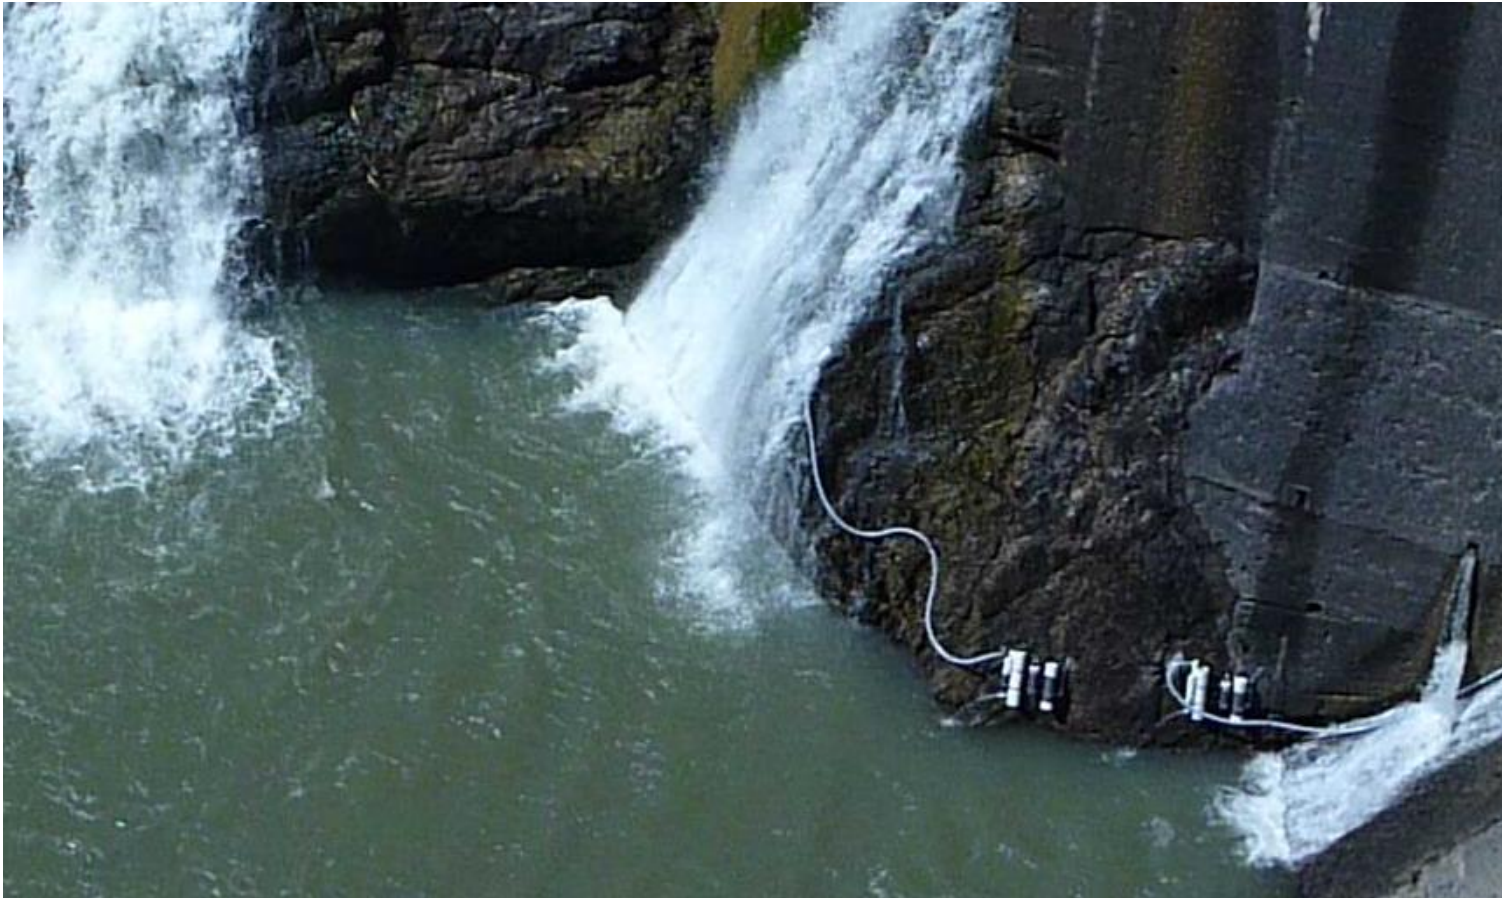
**Plunge pool dye sensors installed**

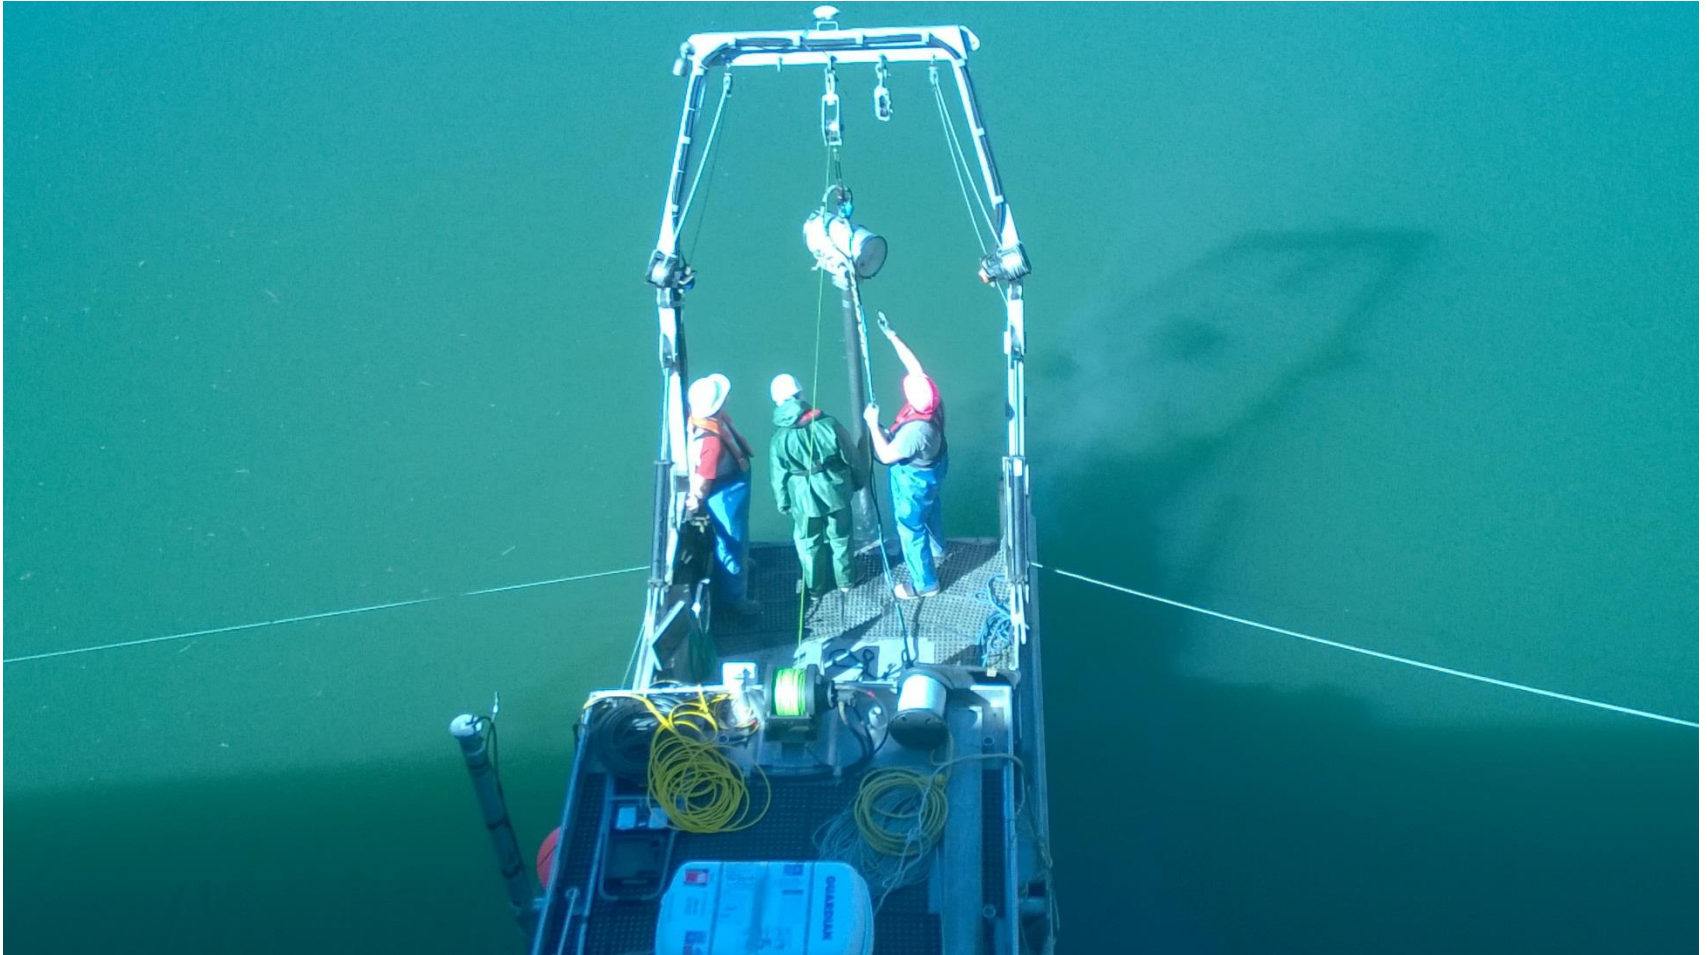
**Conducting vibracore sampling of forebay bottom**

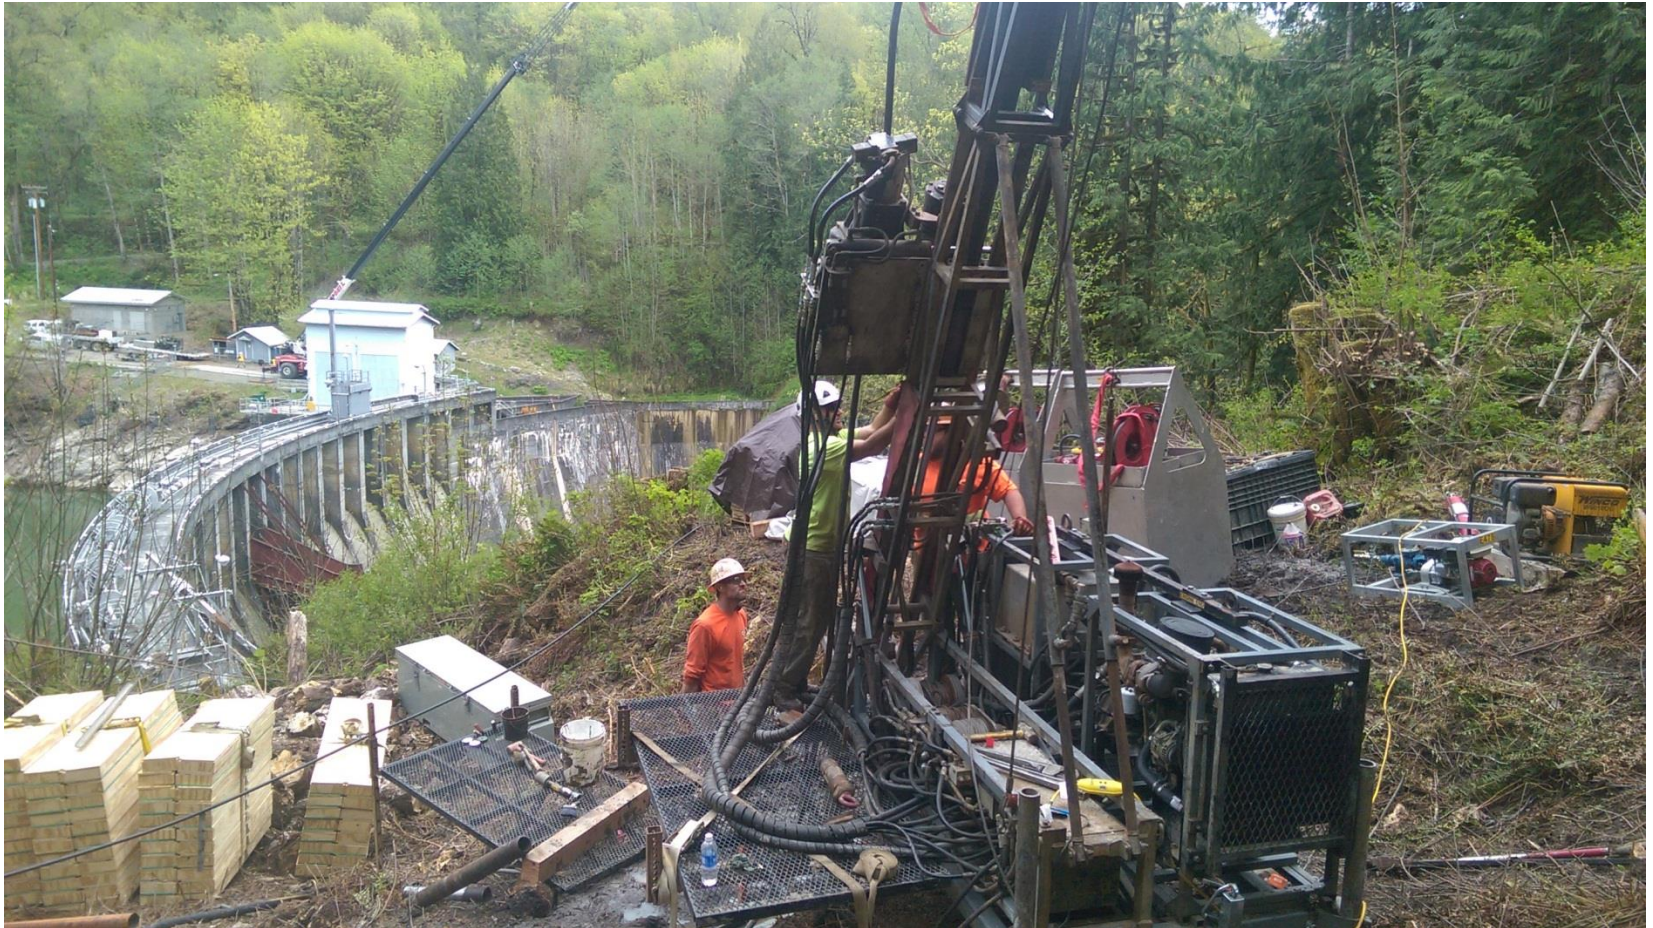
**Core Drill Site on Right Abutment**
